CARLSON ENGINEERING, P.C.

Re: Building Inspection
502 South Main
TAPCO Building
Rockford, IL

Re: Photographs Page 1
502 South Main
TAPCO Building
Rockford, IL

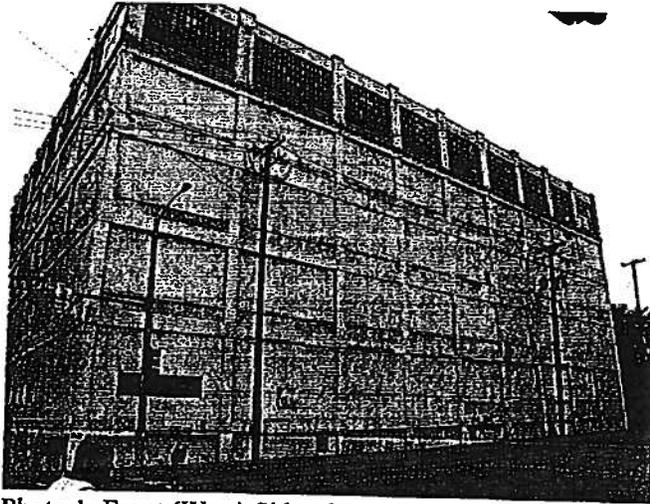
Photo 1: Front (West) Side of Building

The front of the building is assumed to face west along Main Street as shown in the attached photograph #1. Photograph #2 was taken from the northeast corner of the building. Photograph #3 was taken from an upper floor of the building located to the north. As can be seen in the photographs, the east or back side of the building has 6 full stories exposed above grade. The grade slopes from the back of the building up to the front of the building leaving 5-1/2 stories exposed at the front.

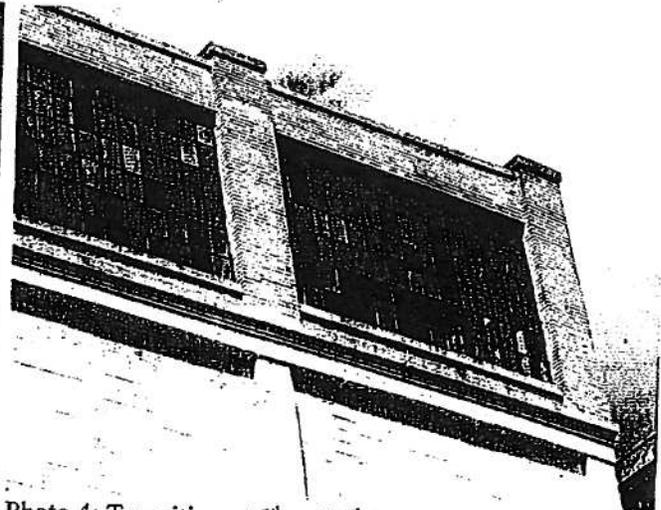
At the back of the building I noted that dates had been embedded into concrete blocks set into the building. At the bottom of the 4th floor level the date was 1907 and at the roof level the date was 1915. I also noted a transition in the type of construction between the 5th and 6th floor levels as can be seen in photograph #4. The first five floors were reinforced concrete construction with concrete block used to fill what must have at one time been window openings, and the 6th floor appeared to be a load bearing brick with steel lintels over window openings. Based on this it appears that the first 5 floors of the building were constructed in 1907 and the 6th floor was added in 1915.

Photo 4: Transition at 5th and 6th Levels

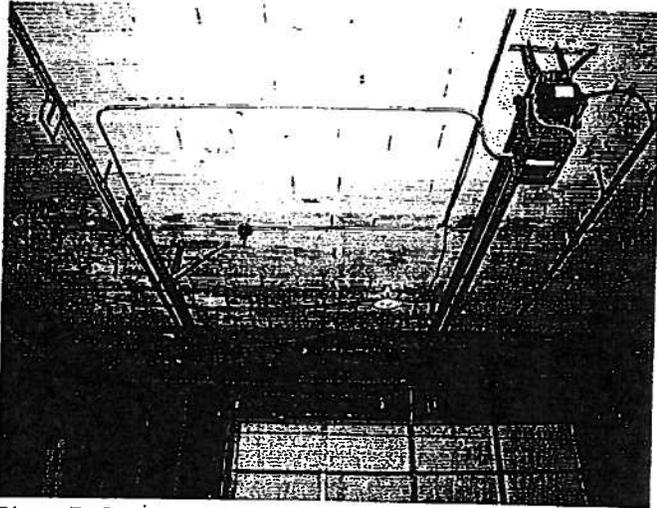
I then proceeded to the interior first floor level of the building where I noted that the 2nd floor above had been constructed using reinforced concrete joists spanning north-south between girders which ran east-west between column locations. The beams had been formed with clay tiles set between the beams which became permanently embedded in the floor system as can be seen in photograph #7. In general the floor slab appeared to be in good condition.

Photo 7: Concrete Floor Joists Formed With Tile

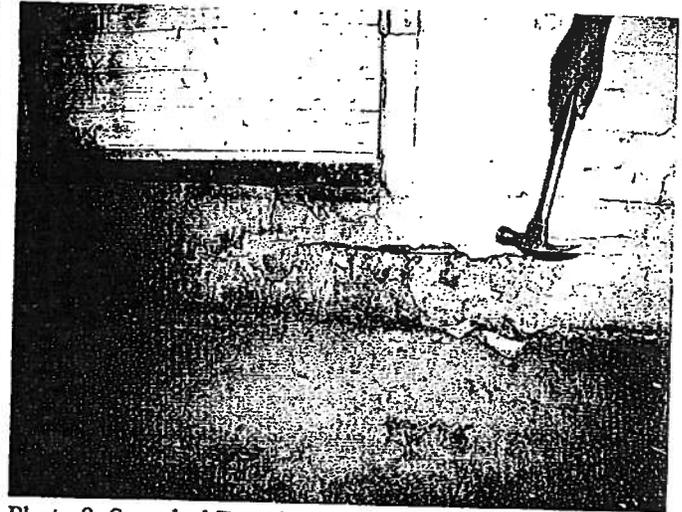
From within the 2nd floor level I noted deteriorated spandrel beams, photograph #8, and deteriorated perimeter columns, photograph #9, in the form of spalling concrete and exposed reinforcing steel.

Photo 8: Spandrel Deterioration

The severe level of deterioration noted in most of the spandrel beams may require that the spandrel beams be removed and replaced or reinforced with a steel beam installed underneath. If testing is done to determine the size, quantity, and location of reinforcing steel it may be possible that the undamaged section of some spandrel beams have adequate reinforcing steel remaining to safely support all required loading.

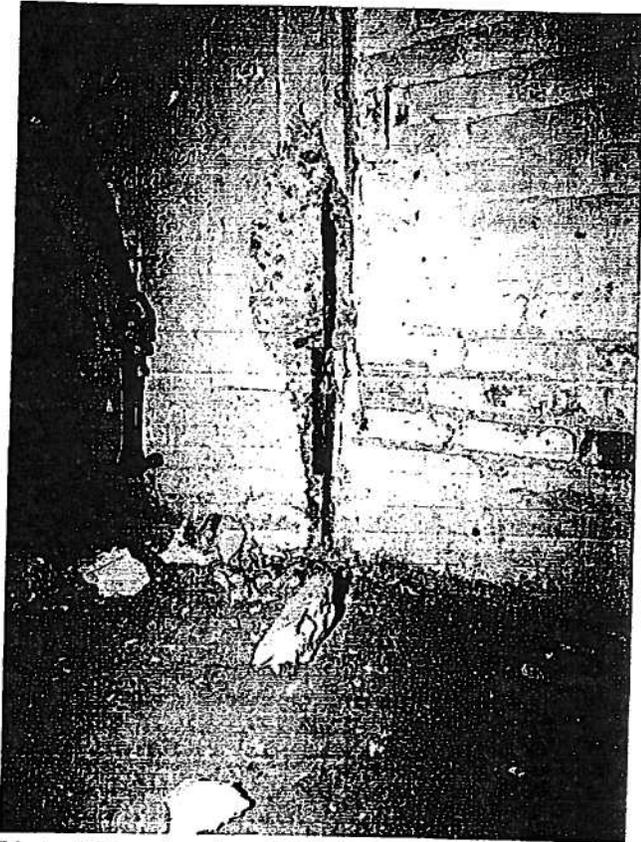
Photo 9: Deterioration of Column At Interior

The visible deterioration of the columns at the exterior did not appear to be as severe as the spandrel beams. Cleaning and patching of the columns will most likely be an effective repair solution. This may not be true for columns which had deterioration concealed behind an aluminum cover.

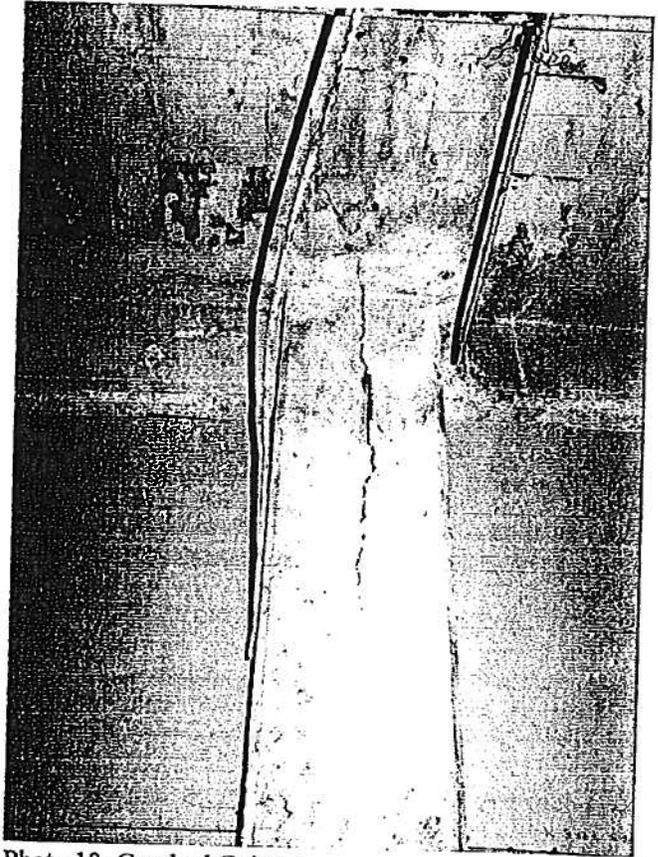
During my inspection of the second floor level I noted that all of the interior and exterior columns which I inspected were cracked at the north and south faces. A typical crack is shown in photograph #10.

The cracks located on the north and south faces of most of the building columns at floors 2 through 5 is of significant concern. These cracks appear to be the result of tension forces along the top of the beams not being properly resisted by reinforcing steel which should be continuous and pass over the column locations. It could be that the steel reinforcing is in place but it is inadequate, or it could be that the steel was never properly installed.

Photo 10: Cracked Column

I recommend that testing be done to determine the location and size of steel reinforcing within the building's columns and beams. Some of this testing will most likely be destructive. With this information the building can be analyzed for current code required lateral and gravity loading and recommendations for repair or reinforcement of the building frame can be made. Reinforcement of the building frame may include the installation of permanent shear walls at the corners of the building. Repair may include reinforcement of the cracked columns with steel strapping or carbon fiber.

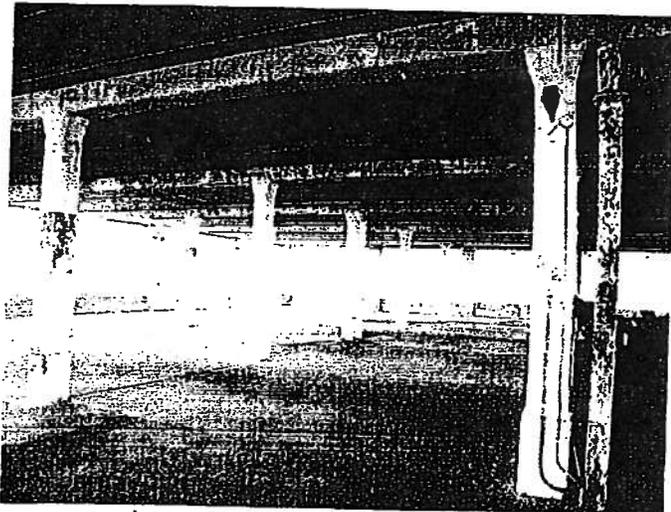
The construction at the 6th floor level was different than the floor levels below. The exterior walls were brick with steel lintels over the window openings. The roof system utilized encased steel beams supported on concrete columns. The roof structure above the steel beams was not visible as it was concealed above wood decking. Photograph # 13 was taken at the 6th floor level.

Photo 13: 6th Floor Level Showing Roof Structure
